CONTINUING ELIGIBILITY INSPECTION (CEI) REPORT
FOR HURRICANE & SHORE PROTECTION PROJECTS
Honolulu Engineer District
CEPOH-EC-T

1. Project Name: Kahului Wastewater SPP

2. Date of Inspection: June 25, 2003

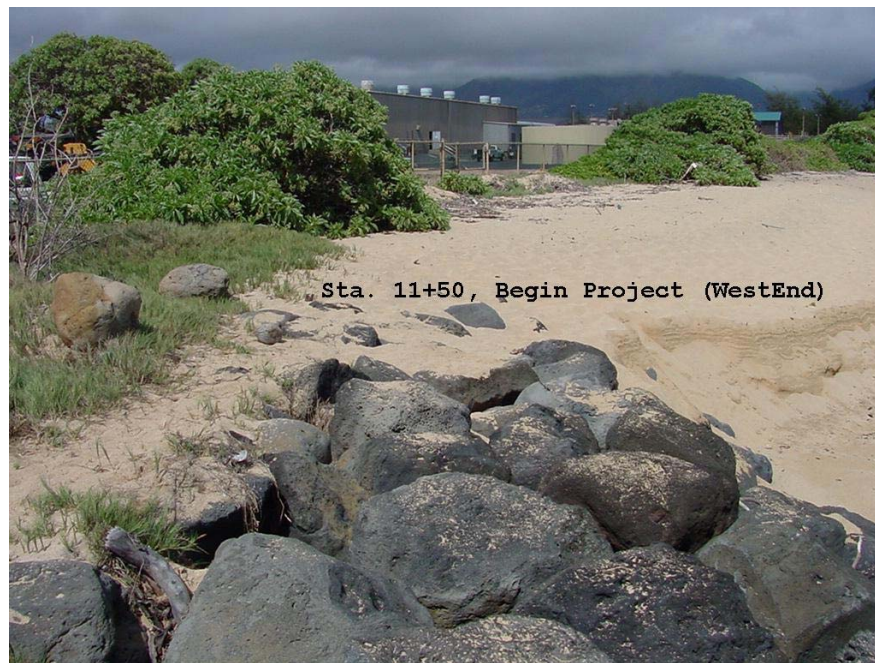
- a. Sta. 11+50, Beginning of project, west-end, photo for reference.

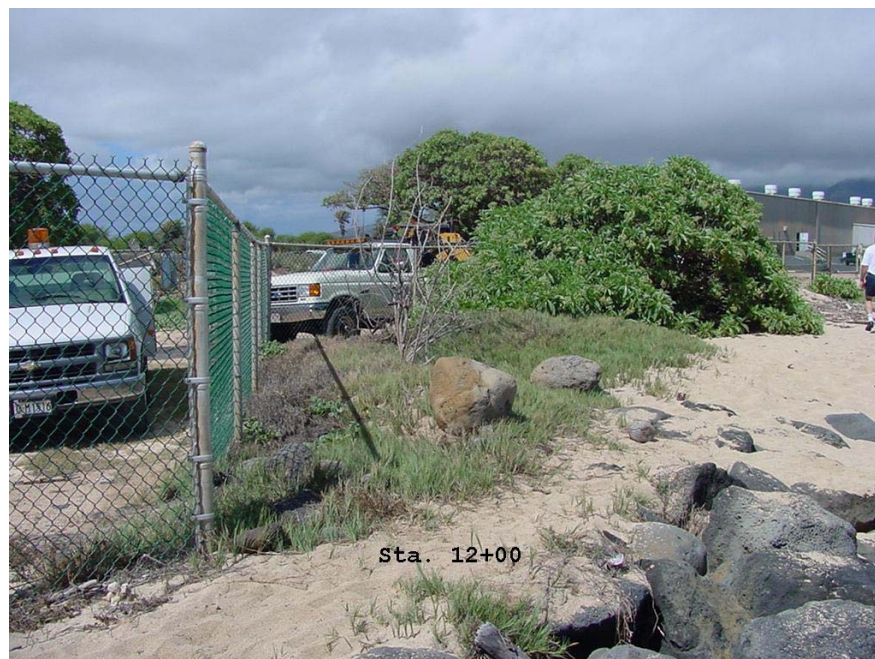
- b. Sta. 12+00, Remove the vegetation from the crest of the structure, as needed.

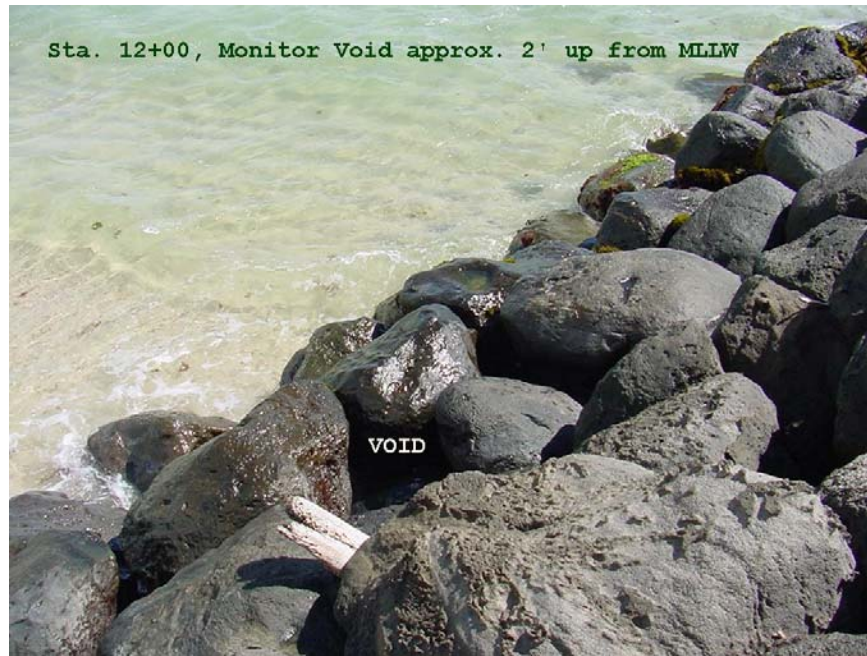
- c. Sta. 12+00, Monitor void 2 ft. up sideslope from toe. New this inspection.

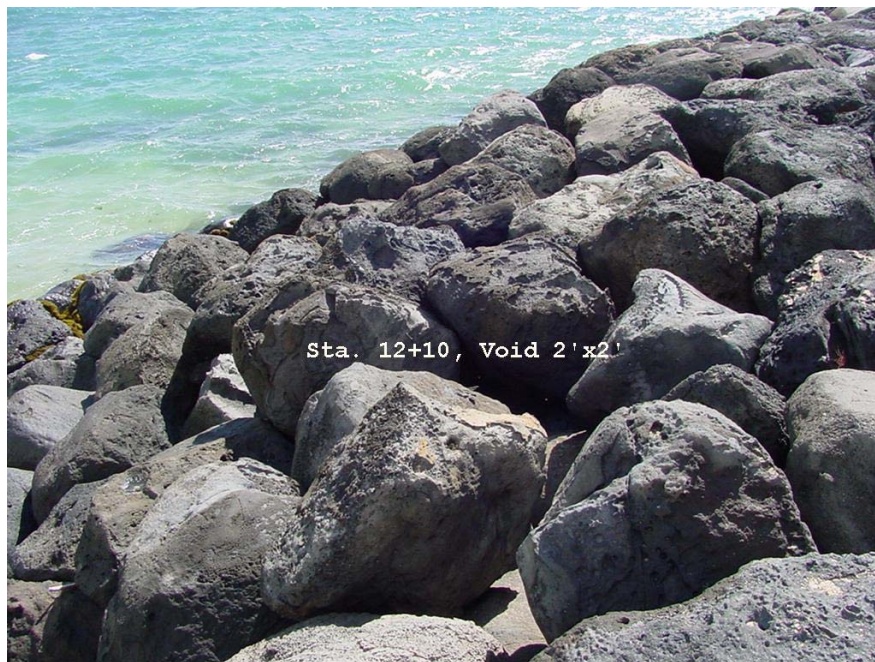
- d. Sta. 12+10, Monitor void on the sideslope. No change.

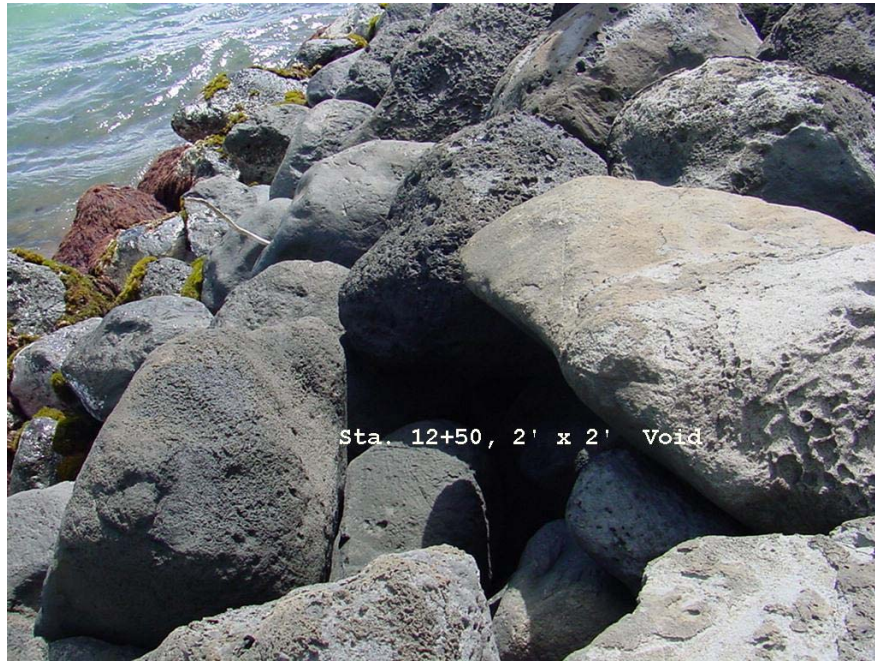
- e. Sta. 12+50, Monitor void and bridging armor stone on the sideslope. No change this year.

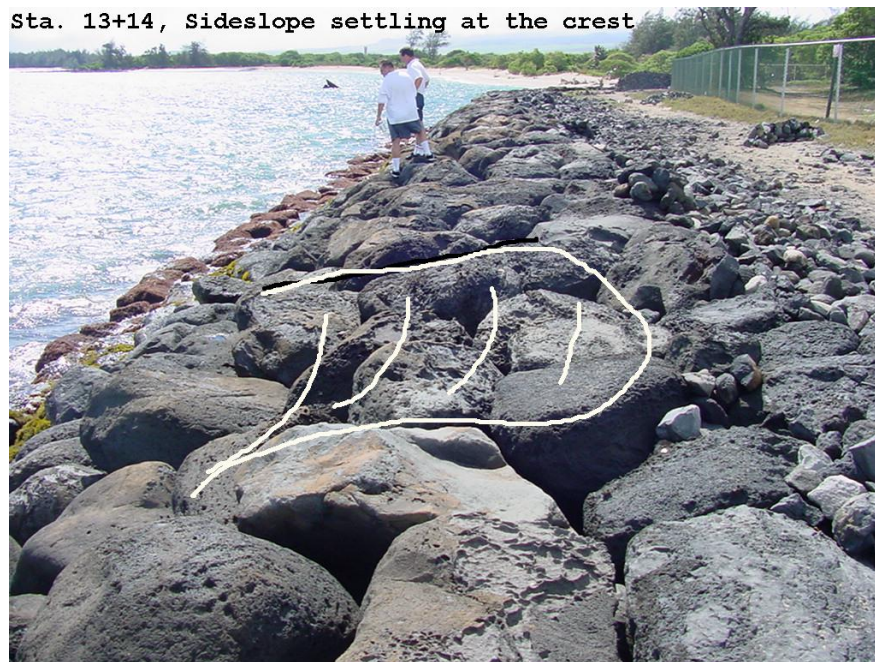
- f. Sta. 13+14, Monitor settling at the crest. No change this year.

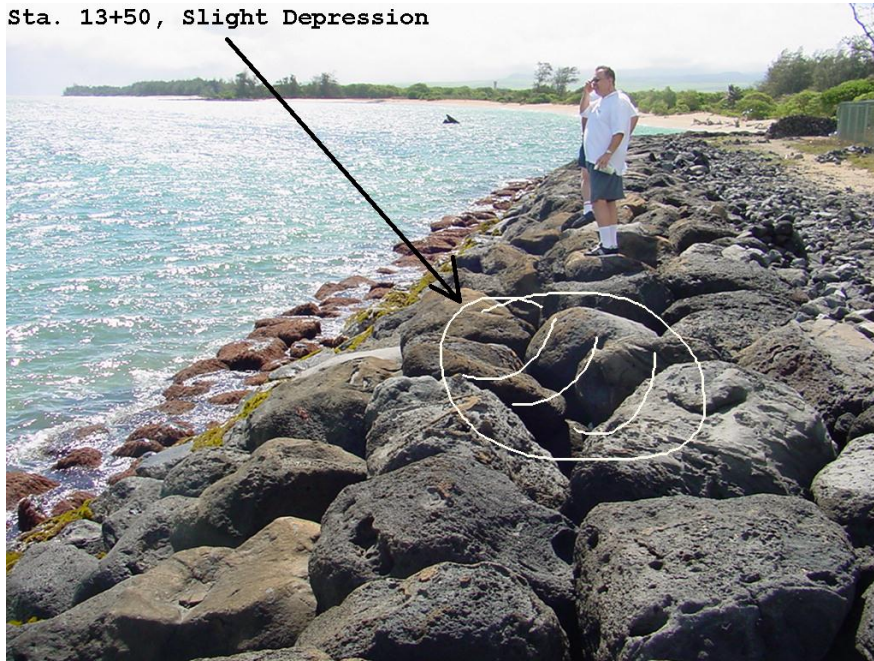
Sta. 13+50, Slight Depression

- g. Sta. 13+50, Monitor slight depression at the hinge.

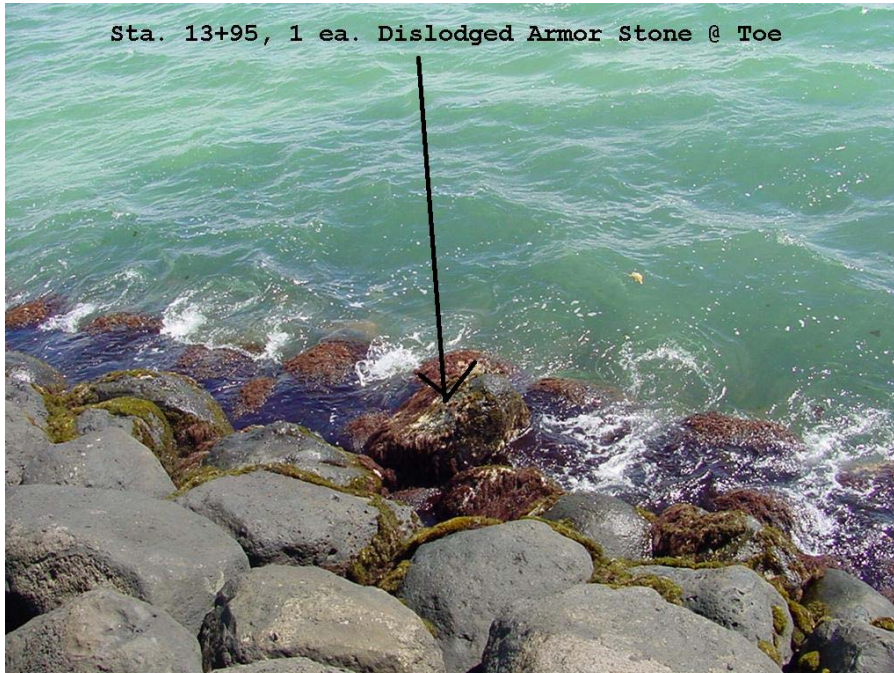
Sta. 13+95, 1 ea. Dislodged Armor Stone @ Toe

- h. Sta. 13+95, Monitor Dislodged armor stone at the toe.
- i. Sta. 14+03, Monitor slight depression at the hinge. Slight Change this year.

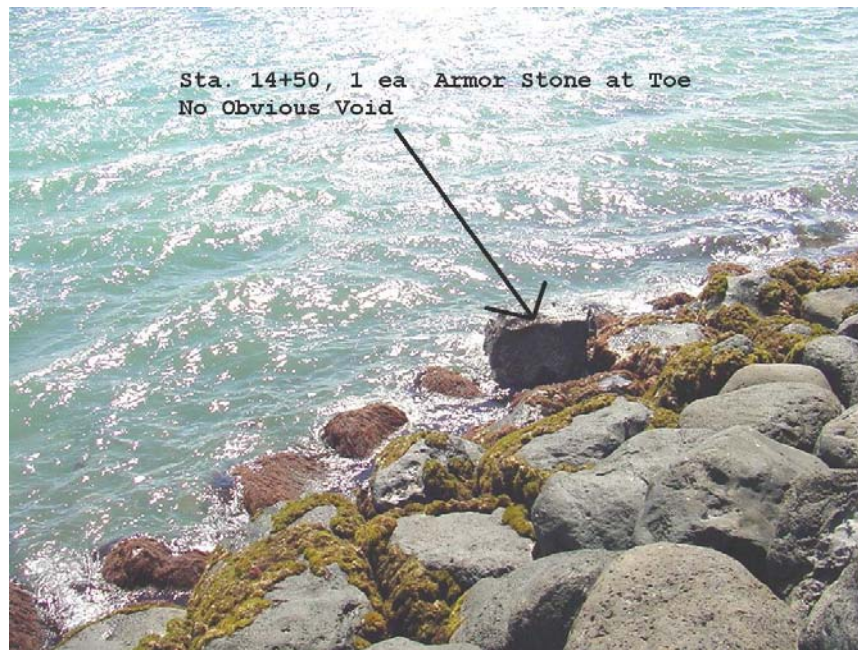
- j. Sta. 14+50, 1 ea armor stone resting at toe, no obvious voids. New this year.

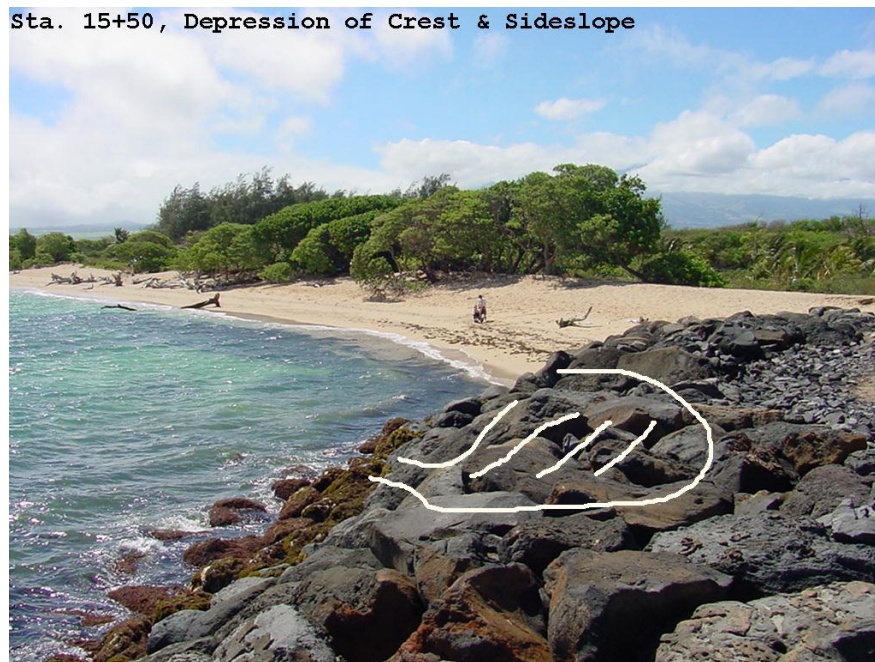
- k. Sta. 15+50, Monitor depression at the crest. Big Change this year. Monitor closely (post storms).

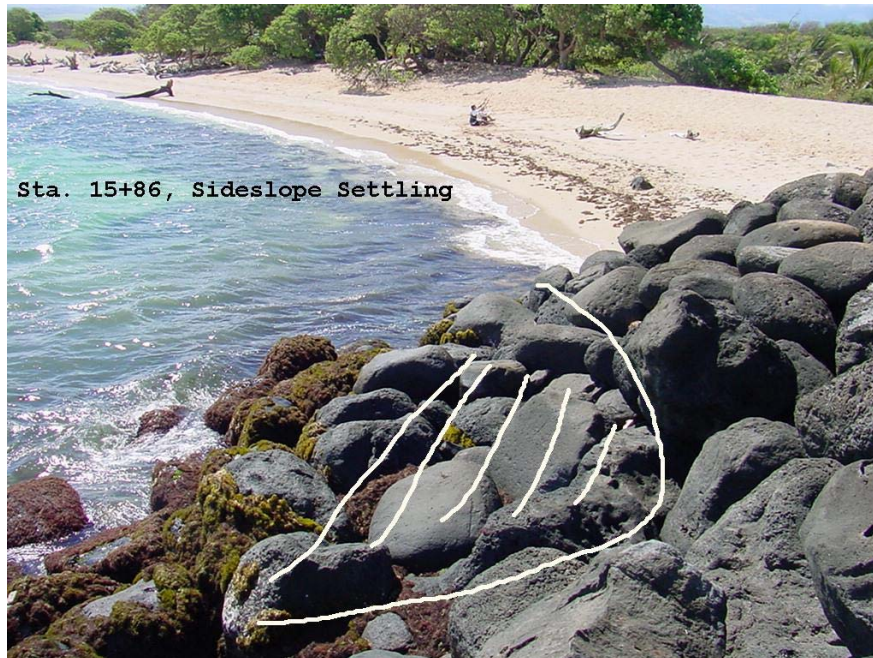
- l. Sta. 15+74 and Sta. 15+86, The void and depression have combined. Monitor sideslope settling and armor stone movement. Approximately 5 armor stones in the water. Big Change this year. Monitor closely (post storms).

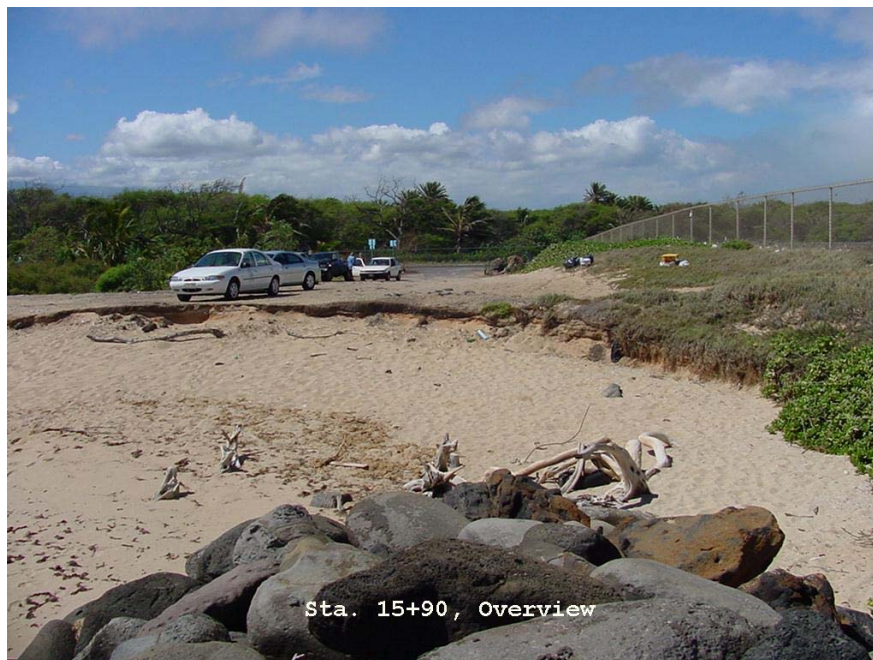
- m. Sta. 15+90, Overview, photo for reference. Additional erosion of sand from behind the structure. Monitor closely (post storm).

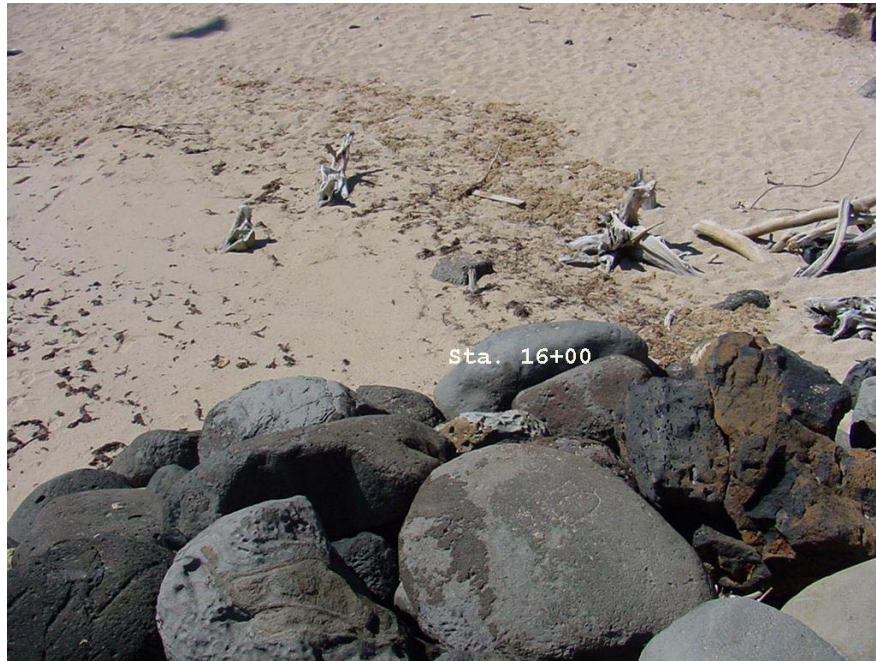
n. Sta. 16+00, Monitor erosion at tie-back, photo for reference.
